## **History Brief**

For Location ID: 0955-034-004 in Unit: 0955

Headline: 5 Year VT Insp, No Issues

OSI Severe weld defect at TML 4-wormhole porisity with 1/2" linear defect

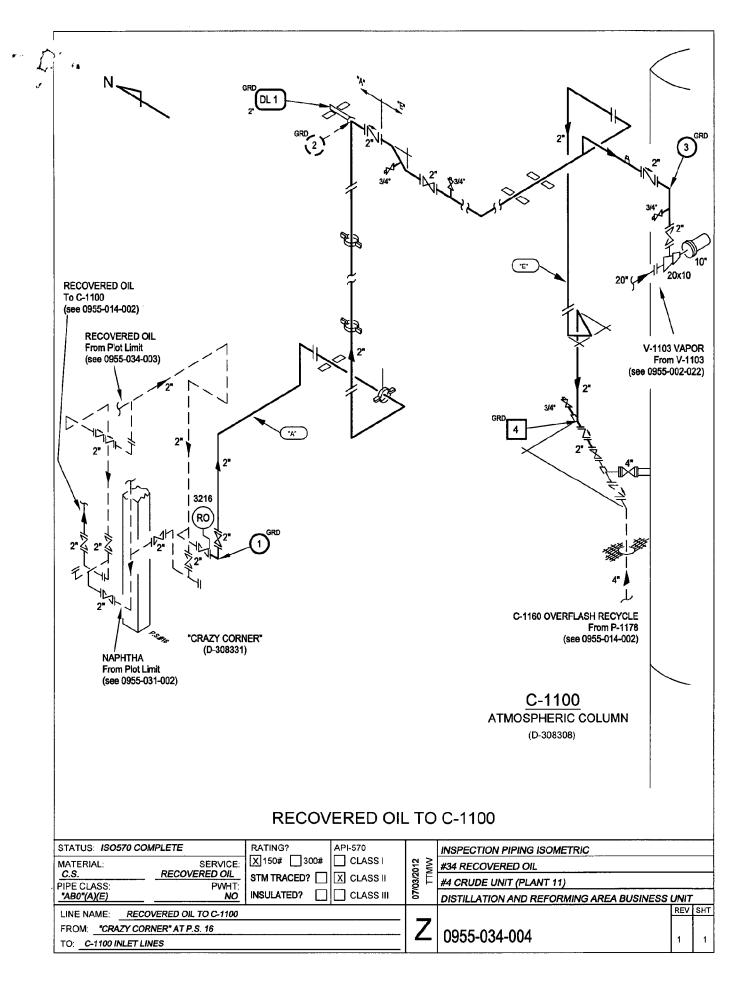
ent Location Location Desc		0955-034-004 RECOVERED OIL TO C-1100						Remaining Life (Years) Retirement Date Last Inspection Date Next Inspection Date Current Corrosion Rate			34.99 11/06/2038 08/09/2005 11/10/2013 1.43	
DP ID	MEAS METH	DP STAT	DP SZ	DT TYPE	BASE	MEAS 5	MEAS 4	MEAS 3	NEAR	LAST	MIN VALUE	CCR	REM LIFE
001.	1 UT	Α	2.00	ELL	0.140 11/96					0.140 01/04	0.100	0.00	$\infty$
001.:	2 UT	Α	2.00	ELL	0.140 11/96					0.140 01/04	0.100	0.00	$\infty$
003.	1 <b>UT</b>	Α	2.00	ELL	0.150 01/04					0.160 08/05	0.100	0.00	$\infty$
003.	2 UT	Α	2.00	ELL	0.150 01/ <b>0</b> 4					0.150 08/05	0.100	0.00	$\infty$
004.1	R RT	Α	2.00	ELL	0.160 11/96					0.150 11/03	0.100	1.43	34.99
